INSPECTION REPORT: KENSINGTON GOLD MINE

Date of Inspection: Thursday June 1, 2017
Date of Report: Monday June 19, 2017
USDA Forest Service Inspector: Richard Dudek

Ranger District: Juneau Ranger District

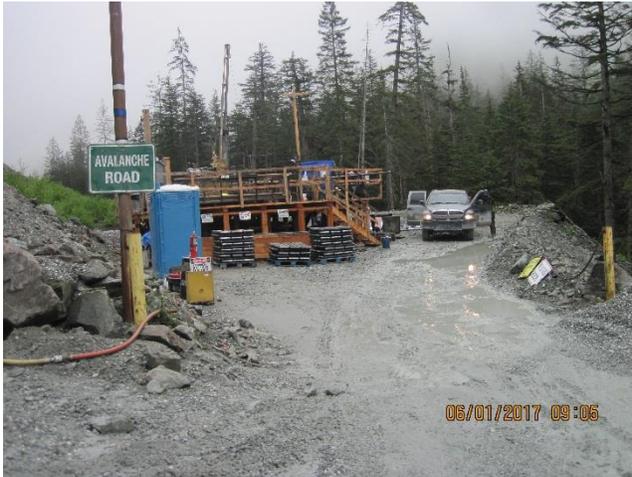
Surface exploration drill is set up near Avalanche Road (Photo 1).

Photo 1. Surface exploration drill located on the Kensington side of the mine site.

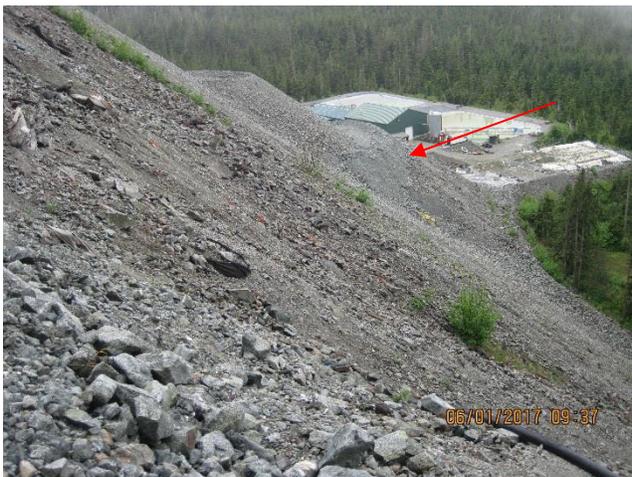
Waste rock from the Raven drift is being deposited on the southwest end of the development pile (Photo 2).

Photo 2. Waste rock from the Raven drift is being deposited at Southwest section of the Comet Development Pile.

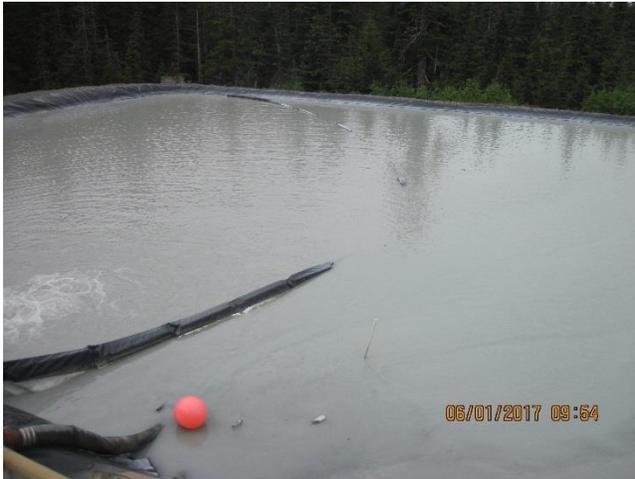
The Comet water treatment plant was treating 2000 gallons of water per minute (gpm). Pond 1 was receiving mine site water, and Pond 2 was inactive (Photos 3-4). The water treatment plant was tidy and in order.

Photo 3. Comet water treatment plant Pond 1.

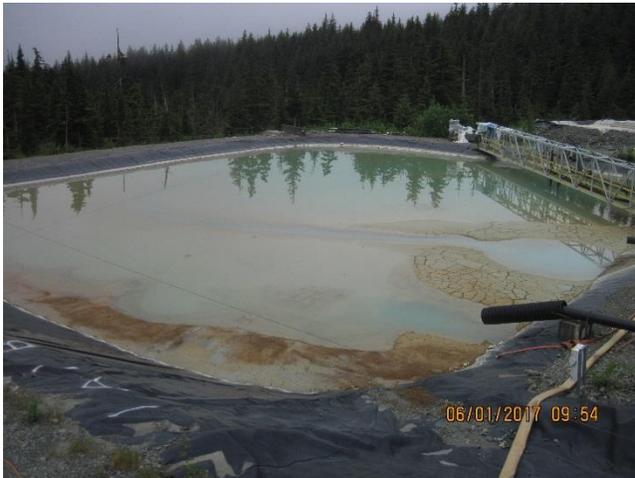
Photo 4. Comet water treatment plant Pond 2.

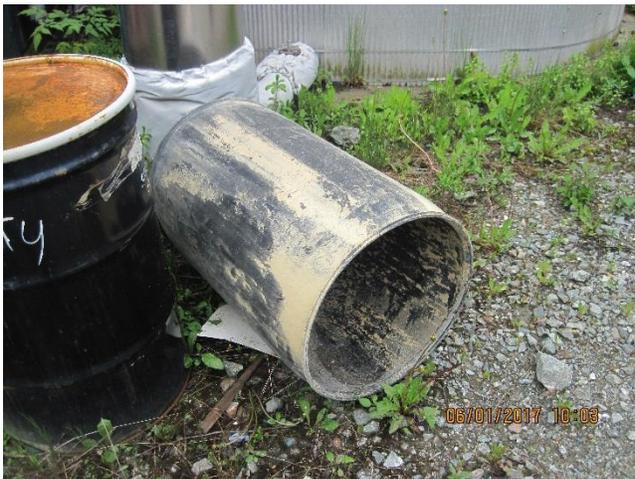
The test barrel was removed for cleaning (Photo 5) and the test rock (Photo 6) was still being used for monitoring white material accumulation in treated mine site water. White material was observed on the test rock and on the non-porous concrete floors below the turbidity meters (Photo 7).

Photo 5. Test barrel used for monitoring white material.

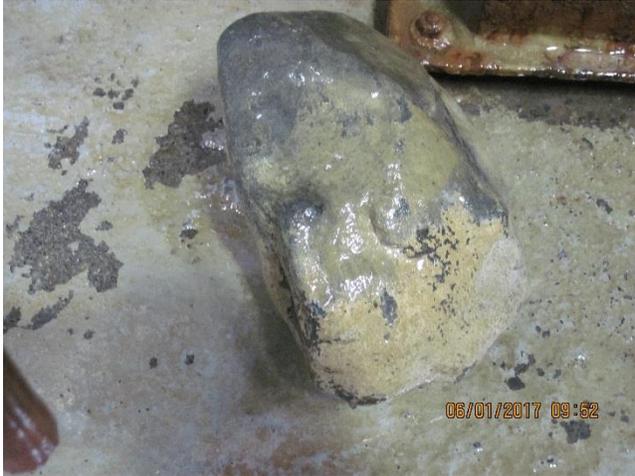
Photo 6. White material test rock.

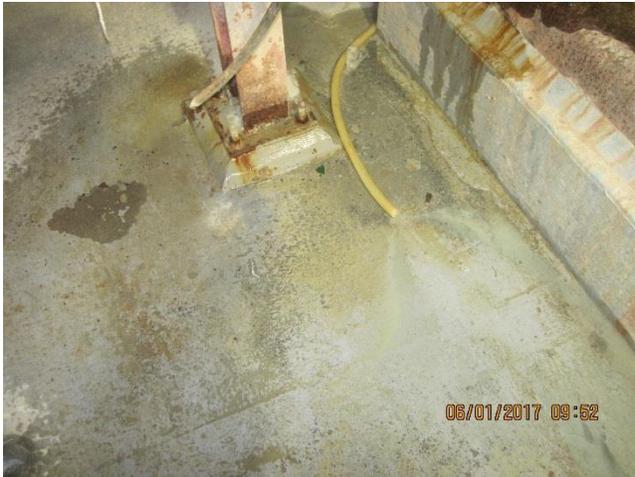
Comet water treatment plant: White material was observed inside the Comet water treatment plant.

Photo 7. White material was observed inside the CTWP.

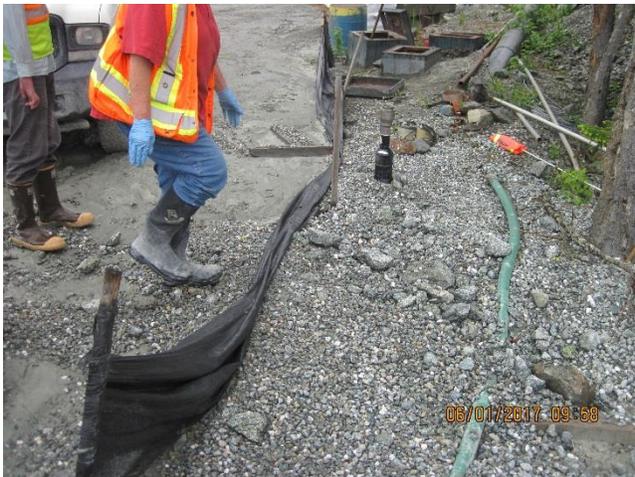
The silt fencing and the trench for storm water conveyance located behind the CWTP requires improvements. The silt fencing and trench were constructed as a mitigation for stormwater conveyance. The silt fence (Photo 8) needs to be replaced with a new one, and the trench needs improvements.

Photo 8. Silt fencing needs to be replaced or repaired.

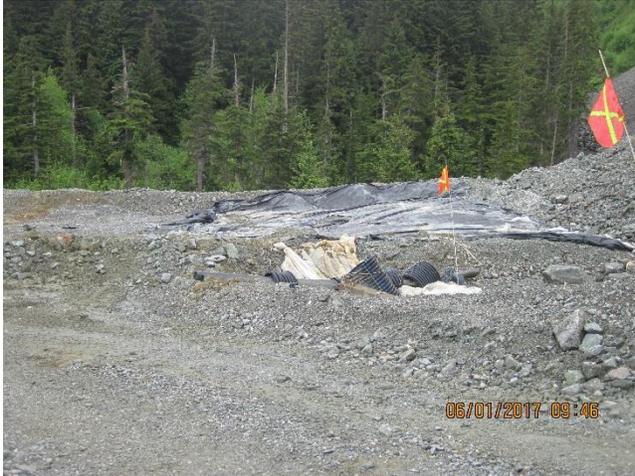
Several dewatering bags were removed with the material being utilized for underground backfill in the stopes (Photo 9). Additional dewatering bags will staged the bags when dredging operations start.

Photo 9. Dewatering bag staging area behind the CWTP.

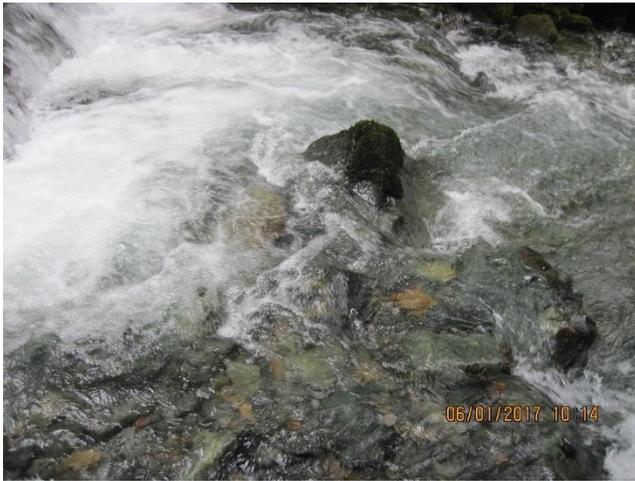
Due to high flows in Sherman Creek, white material may have been washed out (Photo 10). It is assumed that white material is still precipitating within the creek bed due to it being observed in the Comet water treatment plant. Coeur Alaska has submitted a proposal to the Alaska Department of Environmental Conservation (ADEC) to use calcium chloride (CaCl_2) as a coagulant for removing white material out of solution during the water treatment process. Coeur Alaska continues to use a dewatering bag located near the 445 level underground sump to help remove the white material out of water.

Photo 10. Sherman Creek.

White material accumulation in Sherman Creek.

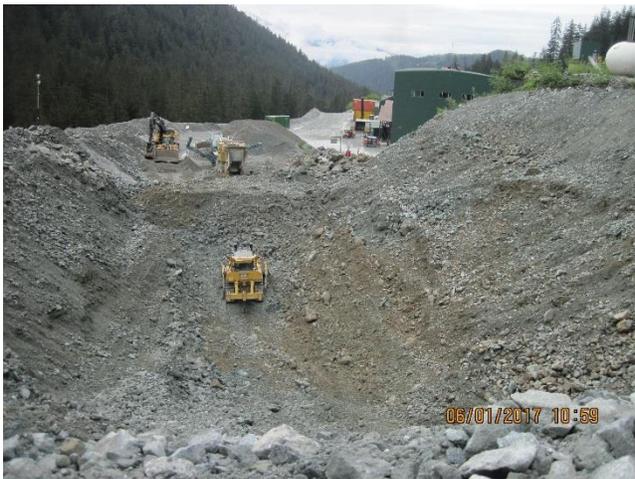
With approval from the Alaska Department of Natural Resources Mining Division, Coeur Alaska recently removed 30,000 cubic yards (yd^3) from the Kensington waste rock pile (Photos 11-12) and stockpiled the material at Pit 4.

Photo 11. 30,000 cubic yards of waste rock was removed from the Kensington Development Pile.

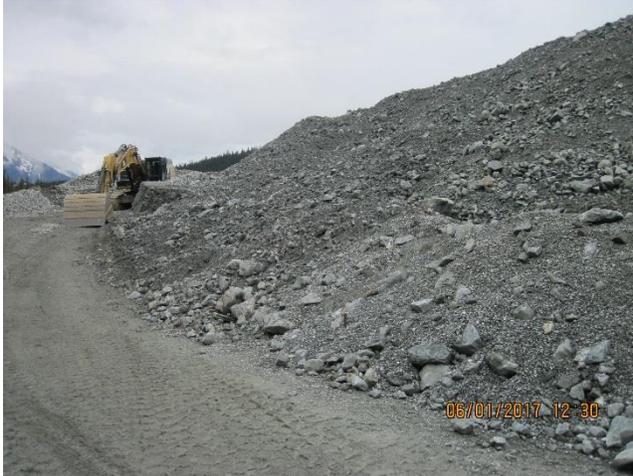
Photo 12. 30,000 cubic yards of waste rock was relocated to Pit 4.

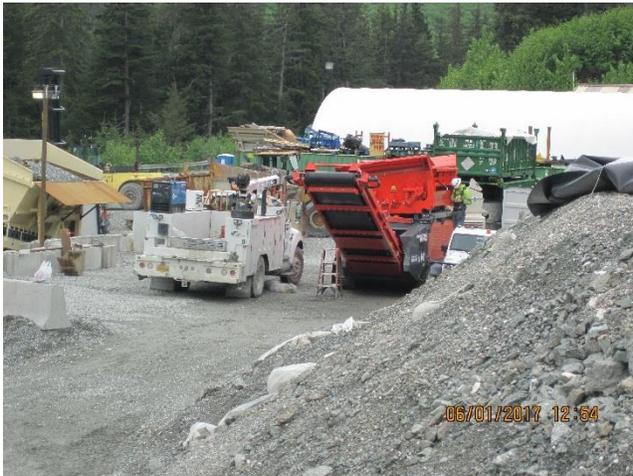
Coeur Alaska recently staged a rock shaker near the Pug Plant (Photo 13). This will separate the large rocks (five inches or greater in diameter) from the GP stockpiles. The smaller rocks will be deposited onto the Pug plants hopper. The larger rocks will be stockpiled behind a graphitic phyllite (GP) stockpile (Pit 4), and encapsulated along with GP into the cement for underground backfill.

Photo 13. A rock shaker (red machine) will be used to separate large rocks from smaller rocks.

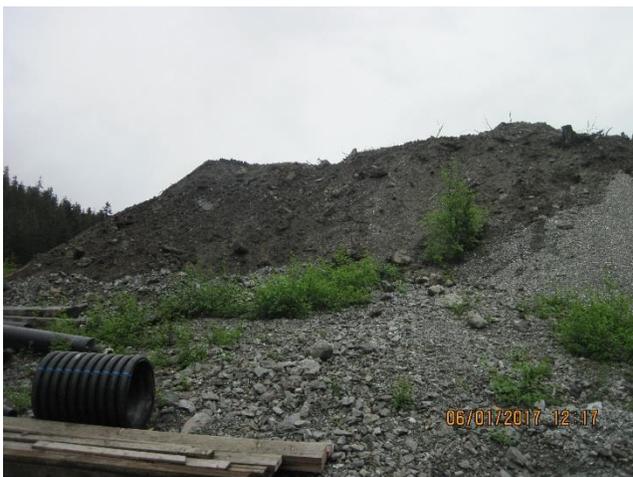
Coeur Alaska plans to keep the 8,000 yd³ soil stockpile at the Mud Dump. To reduce erosion and dust, Coeur Alaska will hand seed the soil stockpile with a USFS approved seed mixture.

Photo 14. 8,000 cubic yards of topsoil was stockpiled at the Mud Dump.

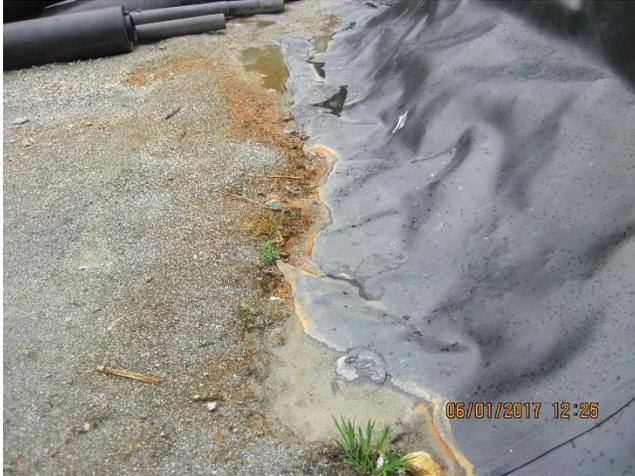
Mud Dump: Reddish color water needs to be tested for ARD that was observed near the edge of the HDPE liner for Graphitic Phyllite (GP) stockpile.

The GP stockpile located at the Mud Dump appears have reddish color water above the edge of the HDPE liner (Photo 15). Coeur Alaska personnel should to test the reddish water for possible acid rock drainage (ARD).

Photo 15. Along the edge of the GP liner at the Mud Dump, reddish color water observed.

Mud Dump's reddish color water results.

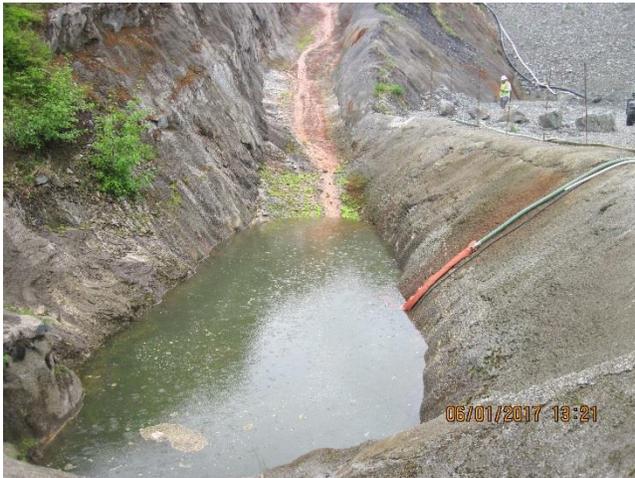
The TTF's water level was 699.0 feet. The TTF water treatment plant was treating 700 gpm, and the reclaim water was 200 gpm. Below the dam, the TTF dam plunge pool's (Photo 16) pipe is jammed. The ARD is currently being pumped into the 40-foot spillway sump. The ARD is then piped to the seep plant for treatment and discharged.

Photo 16. TTF dam plunge pool.

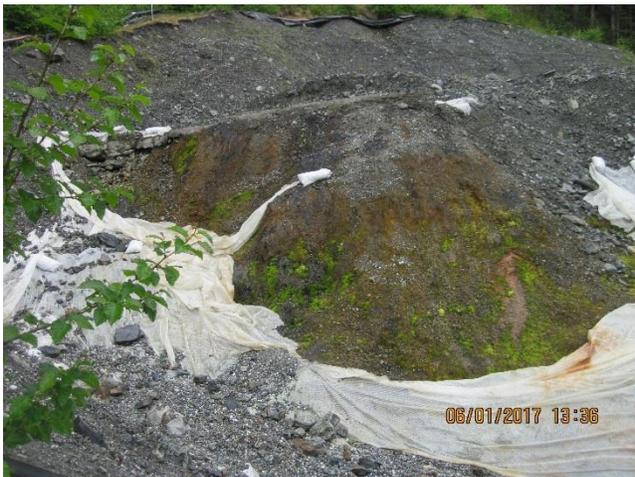
TTF dam: Sections of the liner covering the GP outcrop have separated and need to be fixed.

Below the dam, sections of the liner are not fully covering the GP outcrop (Photo 17). The GP outcrop needs to be fully covered to prevent ARD generation.

Photo 17. GP outcrop liner needs to completely cover the outcrop.

TTF area GP outcrop is completely covered.

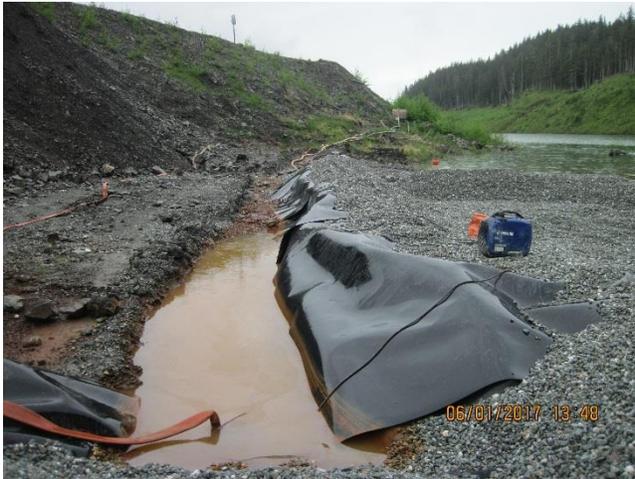
The ARD pH level in the northern TTF was approximately 7.0. The ARD collected in the trench (Photo 18) is pumped into a series of holding tanks. From there, the ARD is hauled by an ARD truck, pumped into the seep plant for treatment, and discharged. The concern with the ARD at this location is the mobilization of heavy metals such as manganese (Mn), cadmium (Cd), and Aluminum (Al).

Photo 18. Northern TTF ARD catchment.

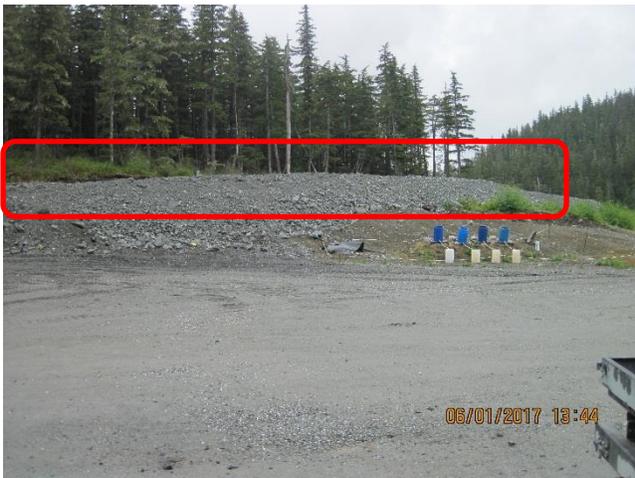
Coeur Alaska recently re-routed the access road for the northern TTF area. Approximately 5,000 cubic yards (yd³) of non-acid generating waste rock was used for the construction of the access road (Photo 19).

Photo 19. Highlighted area shows the location for the new access road at the northern TTF.

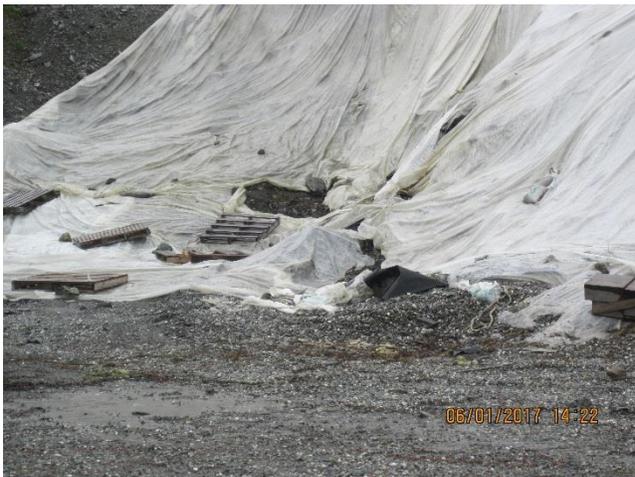
Pit-7: A section of the liner for the GP stockpile has separated and needs to be fixed.

A section of the liner for the GP stockpile has separated (Photo 20). The purpose of the liner is to minimize exposure of the GP to atmospheric conditions, which reduces oxidation and ARD generation.

Photo 20. Sections of liner have pulled apart and need to be fixed.

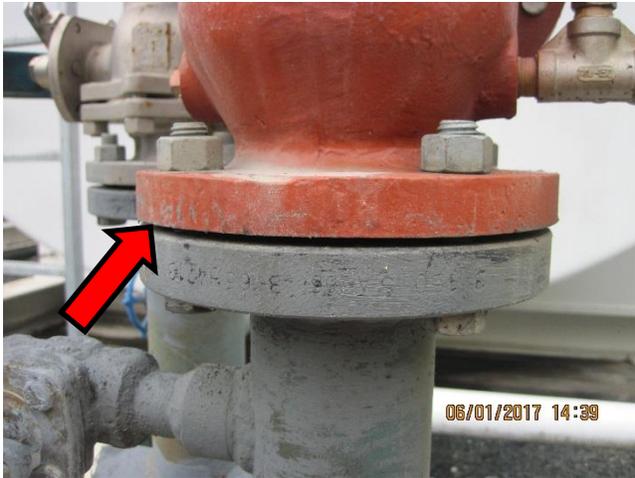
During a previous inspection on 04/22/2017, approximately 8 ounces of diesel fuel was observed below the fuel line for tank-5. Fuel Depot operators were immediately notified, and tightened the pipefittings where the leak occurred. No leaks were observed at the Fuel Depot (Photo 21). The absorbent pads below the pipes remain in place as a precaution (Photo 22).

Photo 21. Pipefittings were tightened where the leak occurred.

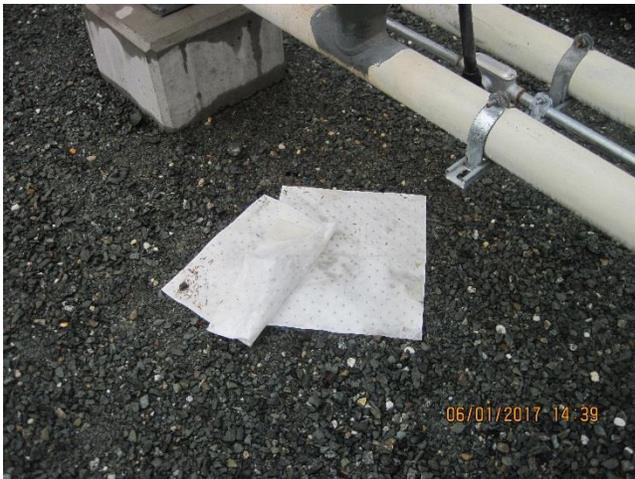
Photo 22. Absorbent pads placed below as a precaution.

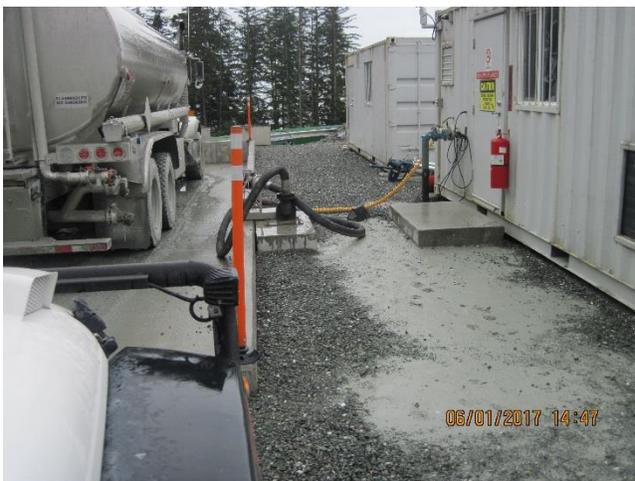
A new flexible fuel line was installed at the refueling pad (Photo 23). The flexible line is easier to use when transferring fuel from tank T-100 to the fuel truck.

Photo 23. The Fuel Depot refueling station.

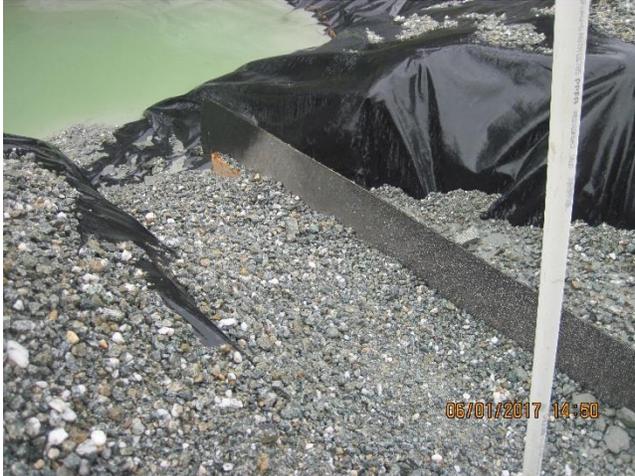
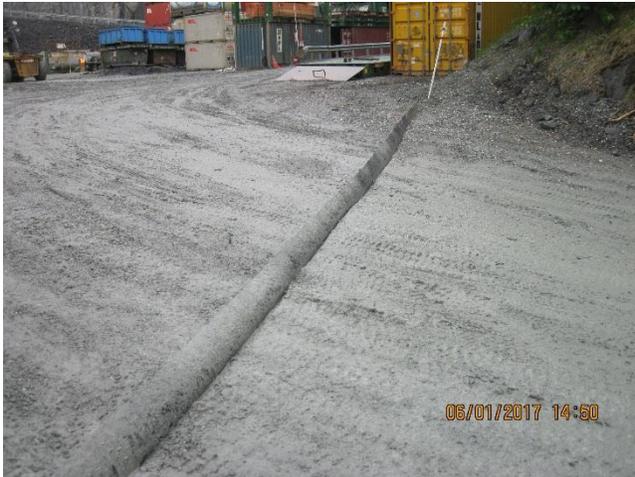
A new water bar was constructed as a mitigation for sedimentation control. The water bar will route storm water into a trench rather than along the access road (Photos 24-25). This will help minimize erosion, flow paths, and sediment loading.

Photo 24. A new water bar was installed near the port facilities (Image 1 of 2).

Photo 25. Water bar (Image 2 of 2).
